Final Report
STUDY METHODS TO STANDARDIZE
THERMOGRAPHY NDE

Contract Number: NAS8-38609
Delivery order: 174

February, 1998

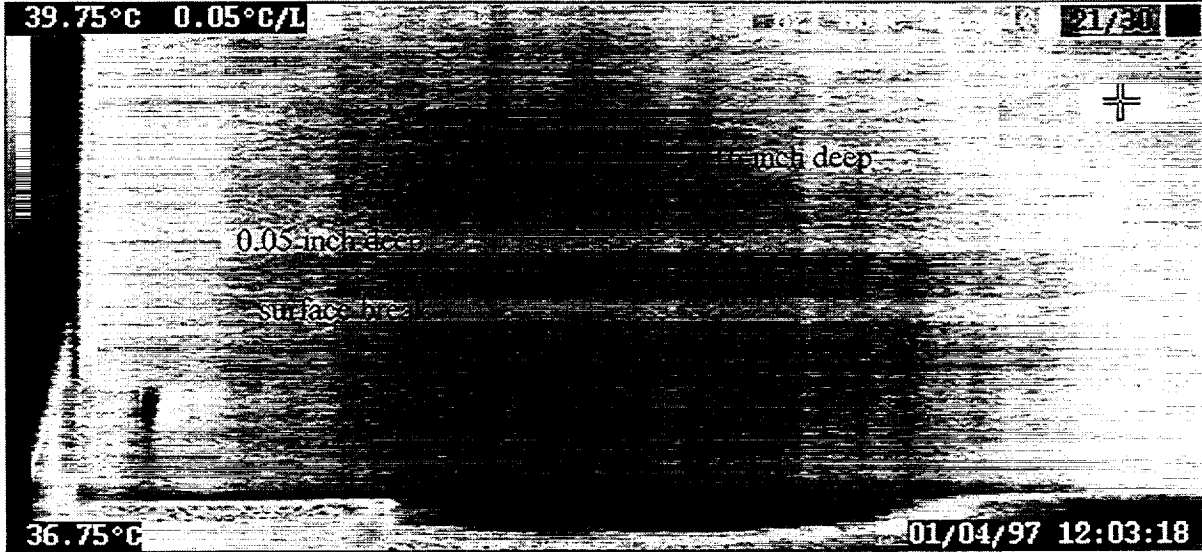
The only holes which were visible were 1/16 and 0.05 inch below the surface. Since the primary defects of interest were over 1/4 inch deep thermography was ruled out as a viable technique for the inspection of the nozzle segments.

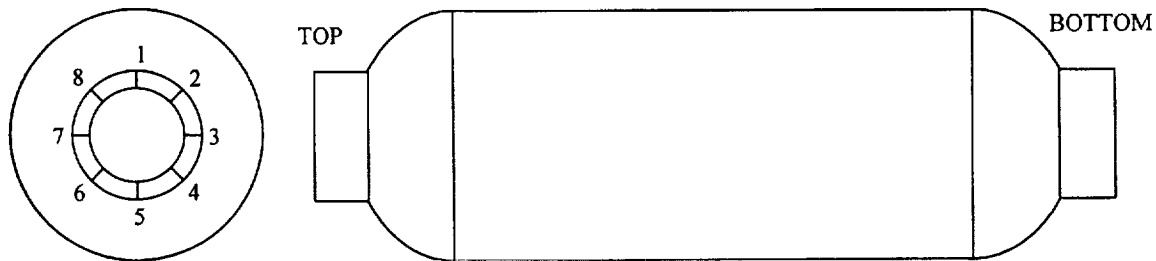
The thermal indications in the hoop region of the side views indicates some possible scattered disbonding of the gr/ep shell from the inner liner. Small hot patches can be seen in each of the side view images. The hot regions would indicate an area where heat from the flash unit was trapped on the surface by a insulating air pocket “disbond” below it. These indications tend to be in the quarter inch square size range. More severe thermal indications are present in the transition region between the hoop and dome. A band of disbonds appears to wrap all the way around the vessel. Some of these transition region abnormalities grow into the hoop and dome region, in the wind direction, which is typical of delamination/disbond growth in filament wound structures.

The end and quarter end views of the vessel shows the same sort of thermal abnormalities as the side views. Small hot regions of potential disbonded shell can be seen to extend all the way around the end of the vessel.

It should be noted that these some of the thermal abnormalities shown may be due to sources other than disbonds, such as resin rich/starved regions, nonuniformity of the inner liner or porosity in the shell itself. To confirm the source of the thermal abnormality a vessel would need to be thermally inspected then dissected.

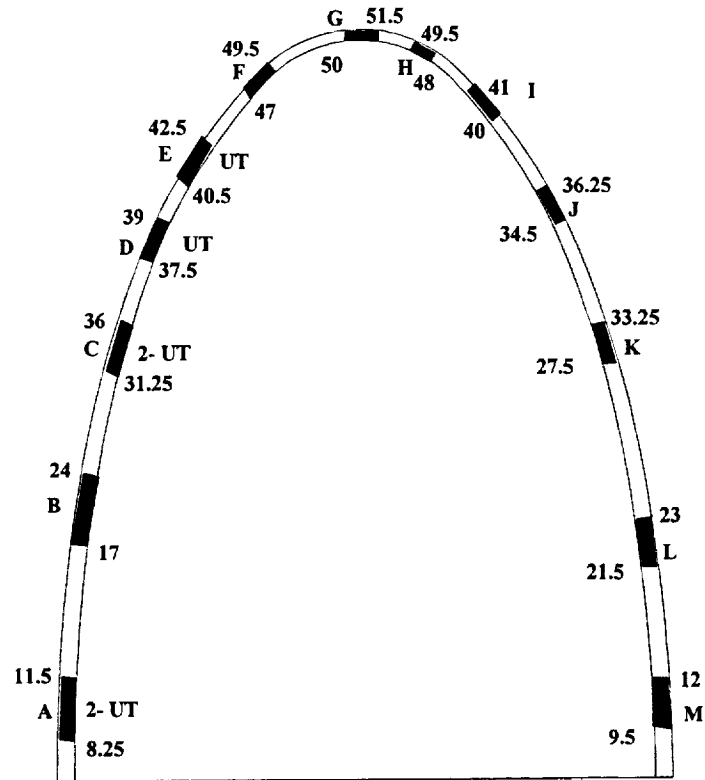
Defect map

The LO₂ feedline fairing had been inspected with ultrasonics and six regions were found to be defective. The regions were located on the fillet at the base of the fairing and were suspected of containing a large amount of porosity. Otherwise, no defects were intended or suspected.

The thermographic inspection yielded 13 potential regions of porosity, including the six previously located by ultrasonics. The following figure outlines the six regions found by UT and the 13 found by thermography. These thirteen regions are also shown on the resulting thermograms.

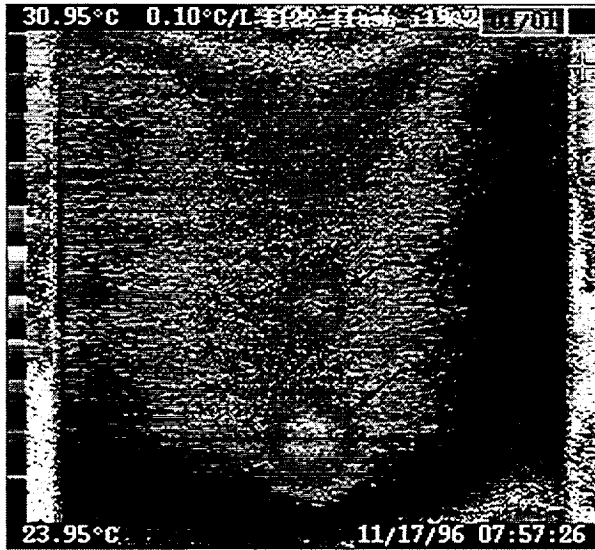
F122 (Missing cobond adhesive defects)

The results of these tests revealed that only the 2.0, 1.0 and 0.5 inch diameter “missing cobond adhesive” defects were identifiable during flash heating. No thermal indications were found using either front or back side manual heating. In fact it was noticed that it was very difficult to get heat through the panel during manual back side heating. Image filtering through convolution with a simple edge enhancement filter helped to identify the defects

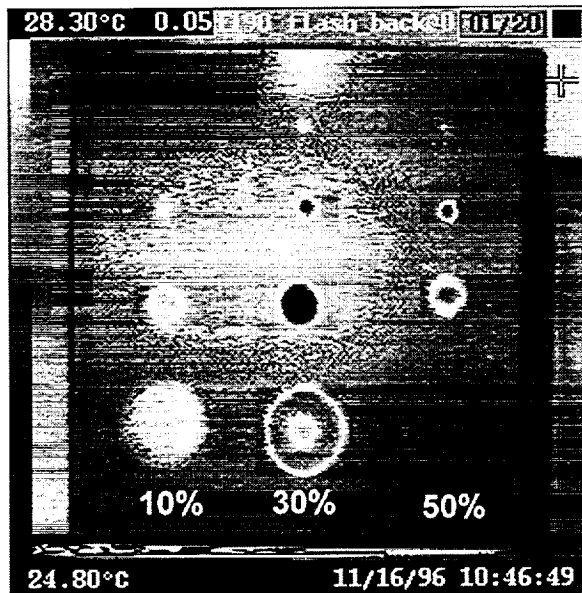
F190 (Back side)

All scheduled defects were found when the back side of the panel “the opposite side from the label” was imaged. These defects are at a depth of 10%, 30% and 50% into the panel.

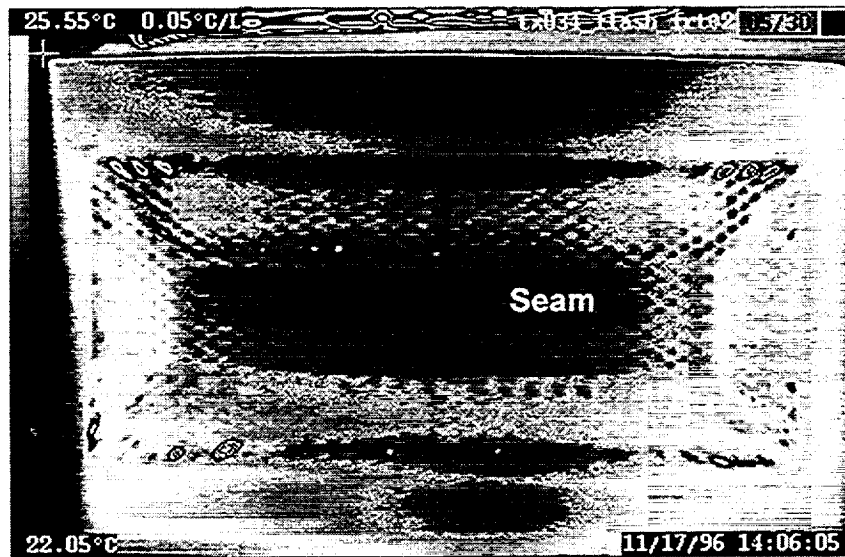
TX034 (120 msec)

The seam is apparent in the thermogram. Also, several hot regions were detected at the fillet between the honeycomb and the edge of the panel indicating possible voids. No thermal abnormalities were apparent during the inspection of the back side of the panel.

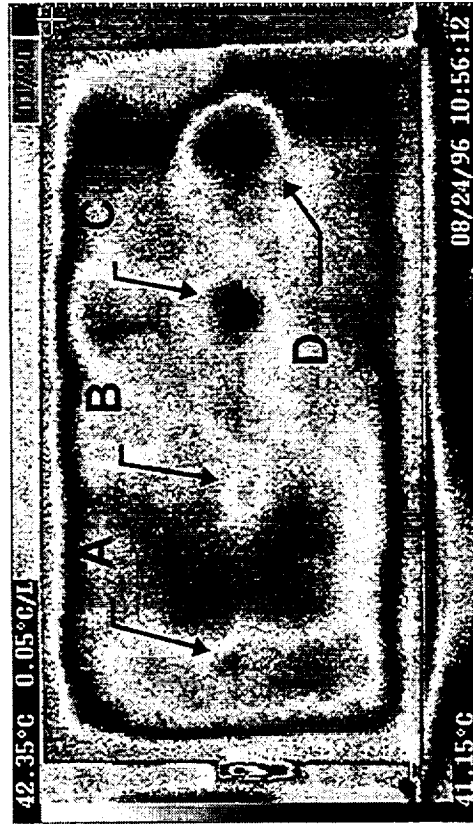
(1) Specimen A - Front side heating by heat gun

Image 1 was acquired with front side heating by a hand held heat gun. The time delay between images was set to 100 msec and images 2 through 21 were archived. In this image all four scheduled defects can be seen. When specimen A was excited with flash heating only the largest three defects could be found.

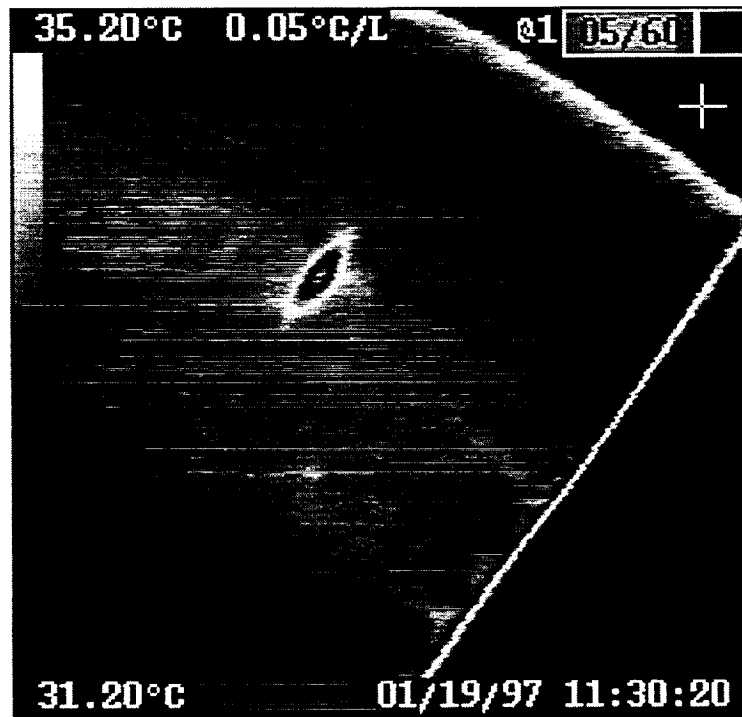
Close-up image of tool mark

The only defects located or identified was a grinding mark, approximately 0.5 inch square, on the inside of the tube. The mark appears to be almost all the way through the tube, but is not visible from the outside. No scheduled defects were planned for this component.
